Standing Committee on Public Administration

Report 14 - “*Unassisted Failure*”

Introduction

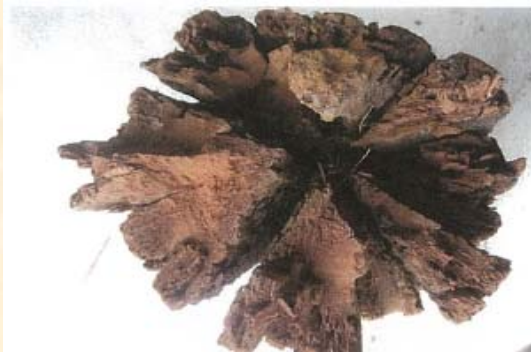
Picture 1. Pole PID# 338949 showing the extent of the rot and five separate sections.

“There was no ‘Good Wood’ left in the cross section at ground line and the pole was in a visually poor condition with large cracks on the circumference.”

“Poles do not reach this level of degrade in only a few years. In my opinion this pole has been misinterpreted and visual signs of decay ignored.”

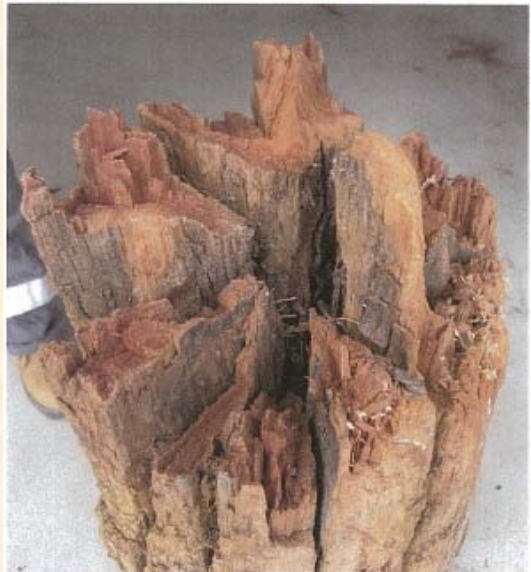
Picture 2. Pole PID# 338949 showing severe rot in the cross section and

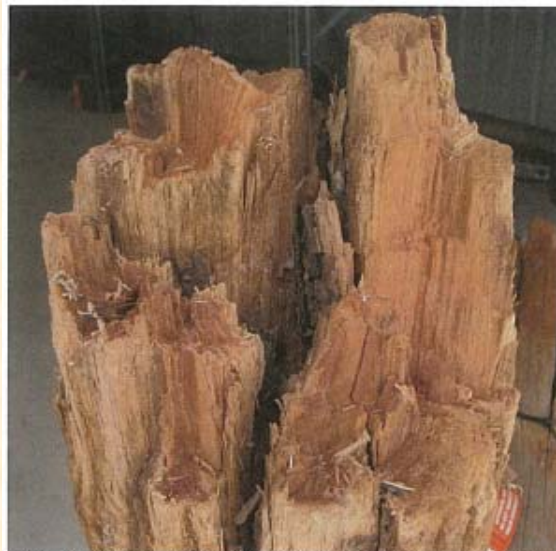
Picture 3. Pole PID# 338950 showing rot and brittle failure in the cross section

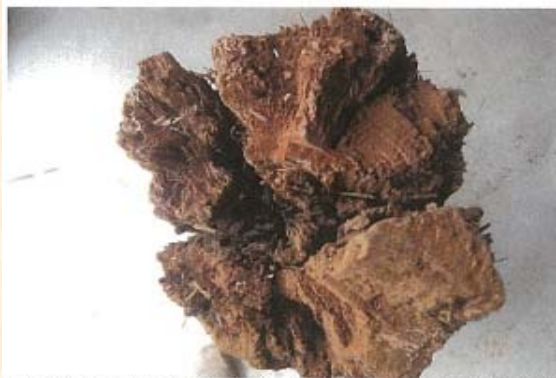
Picture 4. Pole PID# 338950 showing wide cracks in the radial profile and brittle

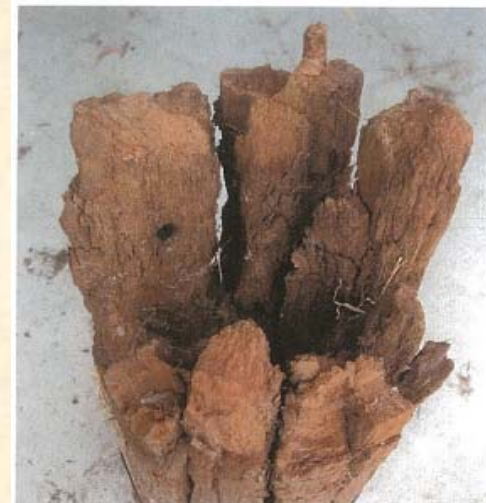
Picture 5. Pole PID# 338952 showing extensive decay and missing timber

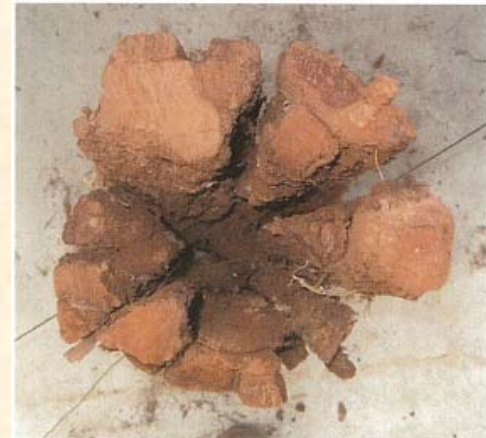
Picture 6. Pole PID# 338952 showing extensive decay and sectionalisation
